Mobile Intel[®] Pentium[®] II Processor Specification Update

Release Date: January 2002

Order Number: 243887-036

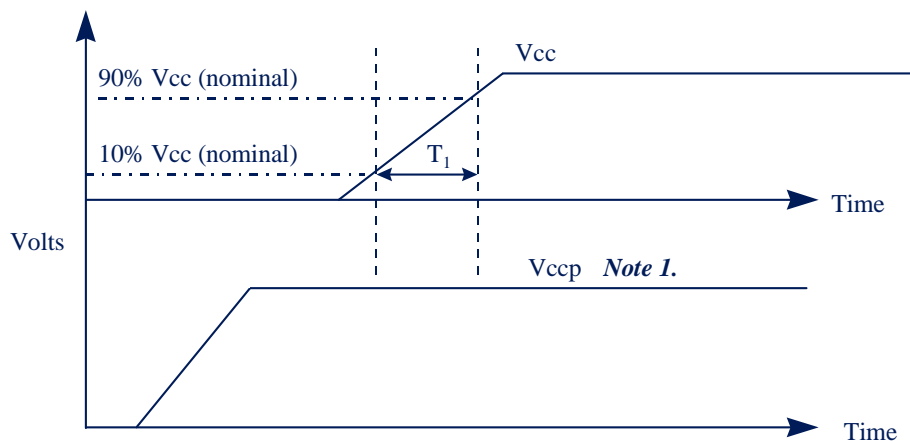
Figure 1. VCC/VCCP Timing Requirements (Mobile)

Problem: The processor uses the PWRGOOD signal to ensure that no voltage sequencing issues arise; no pin assertions should cause the processor to change its behavior until this signal is asserted, when all power supplies and clocks to the processor are valid and stable. However, if V_{CC} ramps up before V_{CCP} , it will cause the processor to enter an invalid state.

Implication: If this erratum occurs, the system may boot normally however, the L2 cache may not be initialized.

Workaround: For Mobile Pentium II processors, ensure that V_{CC} ramps after or with the L2 cache IO voltage (V_{CCP}). If V_{CCP} ramps after the V_{CC} , a delay circuit can be placed on the core V_{CC} to ensure that V_{CC} ramps at the same time or after V_{CCP} as shown below in Figure 1.

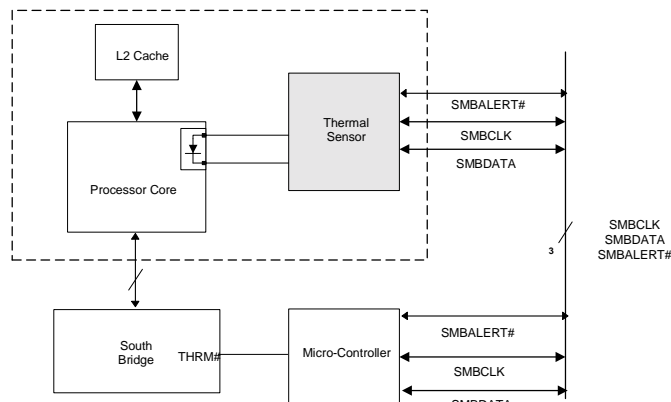
Figure 1. An Example of Microcontroller Driven Thermal Management

Problem: The Mobile Pentium II processor and the Pentium II Processor Mobile Module have a thermal sensor that monitors the processor core's temperature. Please note that desktop systems could have a similar thermal device. The thermal sensor asserts SMBALERT# if the processor temperature exceeds the temperature limits set in the Alarm Threshold Registers (T_{HIGH} , T_{LOW}). It also sets the corresponding Status Register bits to identify the cause of the interrupt. Figure 1 gives one example of the how the SMBALERT# signal could be used in a system.

Under the conditions described below, the thermal sensor incorrectly generates the SMBALERT# interrupt. All of the following conditions must be met to trigger a false interrupt:

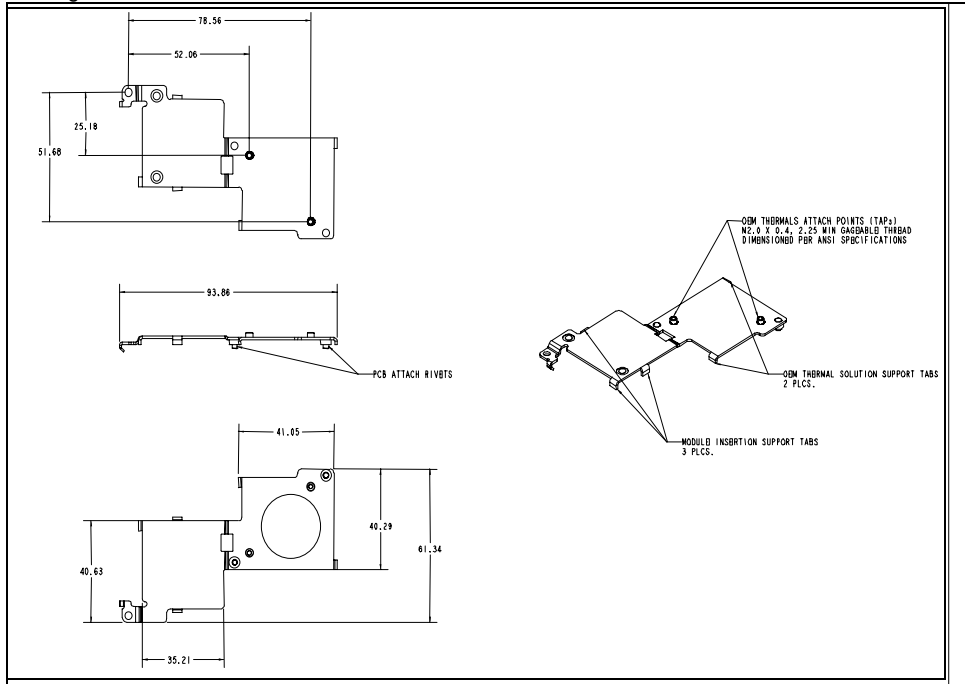
Figure 1. TAP Gageable Thread Clarification

OEM Thermal Attach Points (TAPs) M2.0 x 0.4, 2.25 min gageable thread dimensioned per ANSI specification.
